Manhole Inspection Summary

Manhole # S29EE2014MH

Insp Date: **12/7/06 8:33 AM**

Location Address: **5701 STONY RUN DR**

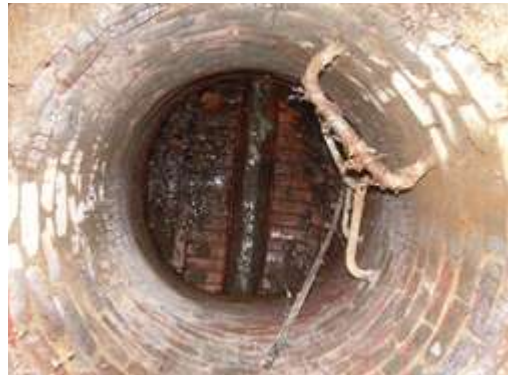
Top View

Corroded steps. Bench debris.

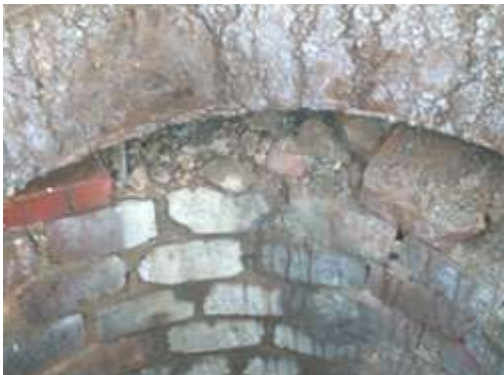
Defect

Frame leaks. Frame offset. Adjustment deterioration, loose brick and infiltration.

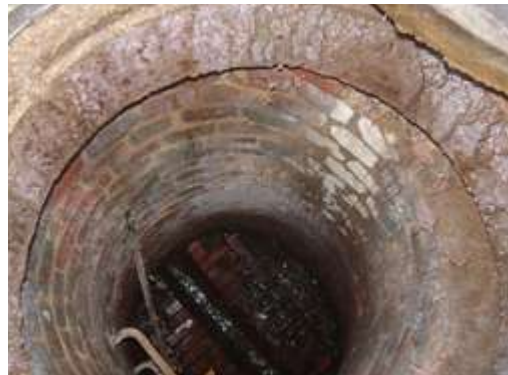
Defect

Frame leaks. Frame offset. Adjustment deterioration and infiltration. Barrel infiltration - other side.

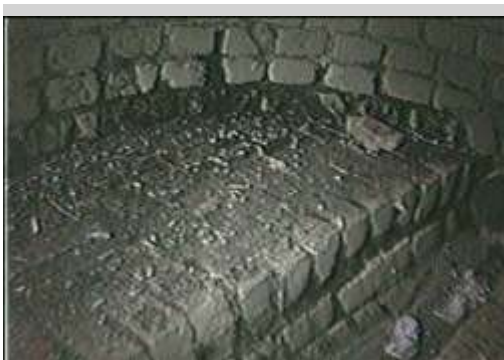
Defect

Barrel infiltration.

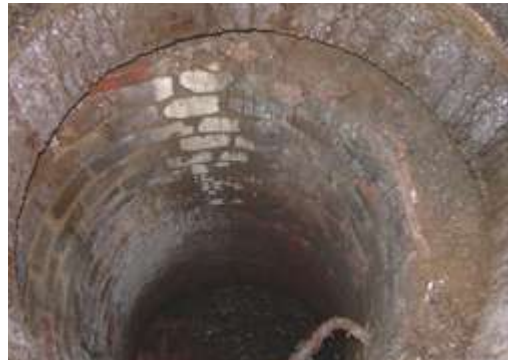
Defect

Frame leaks. Frame offset. Adjustment deterioration and infiltration. Barrel infiltration.

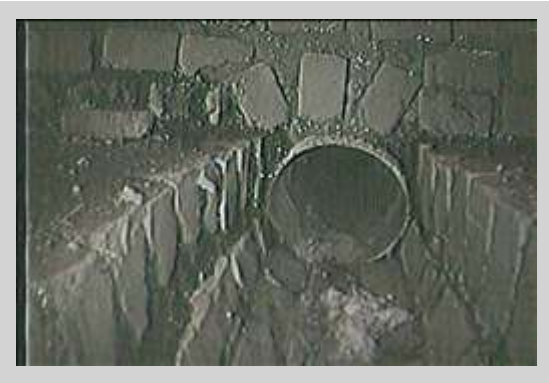
8 in. Circular Gravity Sewer Pipe Out @ 12 O'Clock

Channel deterioration. Barrel deterioration and infiltration. (Active)

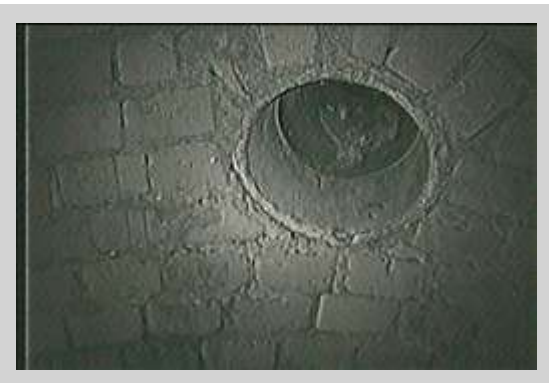
8 in. Circular Gravity Sewer Pipe In @ 6 O'Clock

Infiltration: **Evidence** Pipe Seal Cond: **Unknown**

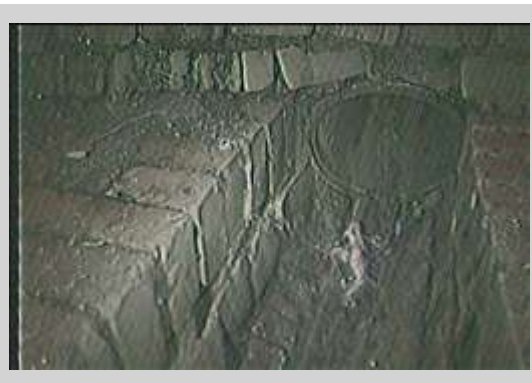
Drop In @ 6 O'Clock

Channel deterioration.
